# **Space-Based Telemetry And Range Safety Flight Demonstration #1**

**Prepared for  
41<sup>st</sup> Space Congress  
April 27, 2004**

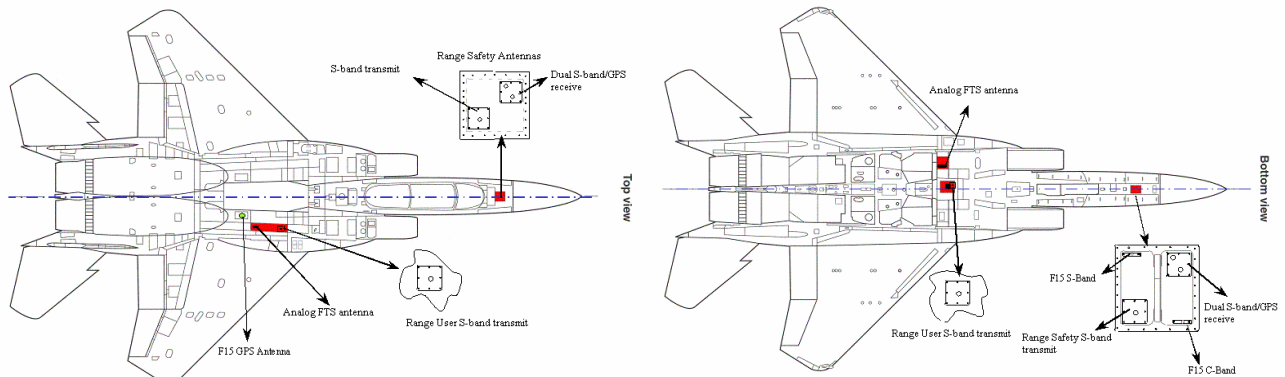
**Figure 2. Antenna Locations on the F-15B**

The locations of the STARS antennas on the aircraft are shown in Figure 2. The Range Safety system used four S-band antennas (~ 4 inches square by 3/8 inches thick) designed and fabricated by Physical Science Laboratories (PSL). There were two antennas on the top of the aircraft and two on the bottom of the aircraft. Each set contained one dual-element antenna for receiving TDRSS/launch-head and GPS signals and another single-element antenna for transmitting to TDRSS/launch-head. The centers of the Range Safety antennas were a few inches off the aircraft's centerline. The top Range Safety transmit antennas were about 27 inches forward of the bottom Range Safety antennas and canted from the horizontal due to the shape of the fuselage.

The Range User system used two transmit-only antennas identical to the Range Safety transmit antennas except for being tuned for different frequencies. One single-element antenna was on the top of the aircraft and another one was on the bottom of the aircraft. The center of the top Range User antenna was about 10 inches forward of the bottom antenna and 48 inches to the right of the aircraft's centerline. The bottom Range User antenna was 3.5 inches to the right of the aircraft's centerline.

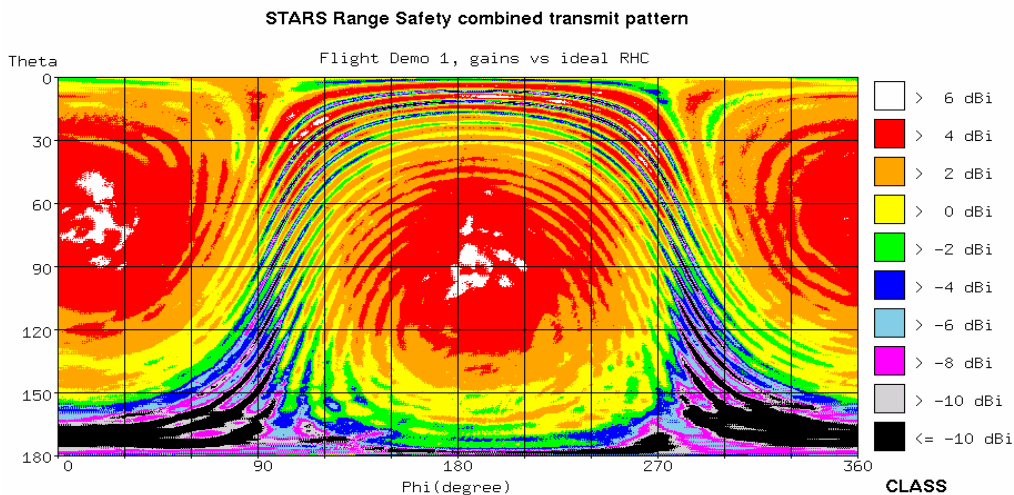
**Figure 3. Range Safety Combined Transmit Pattern**

The Communications Link Analysis and Simulation System (CLASS) Antenna Radiation Pattern Analysis Tool (ARPAT) used a three-dimensional (3-D) F-15 model and the patterns of the PSL antennas to estimate the composite patterns for FD#1. The predicted patterns considered the effects of the mounting on the F-15, the aircraft shape, and interferometer effects. The combined Range Safety transmit pattern is shown in Figure 3. Theta is in the plane dividing the aircraft into right and left halves: 0° at the nose, 90° straight up from the aircraft, and 180° at the tail. Phi is in a plane perpendicular to the longitudinal axis of the aircraft: 0° straight up from the aircraft, 90° out the starboard wing, 180° straight down, and 270° out the port wing.

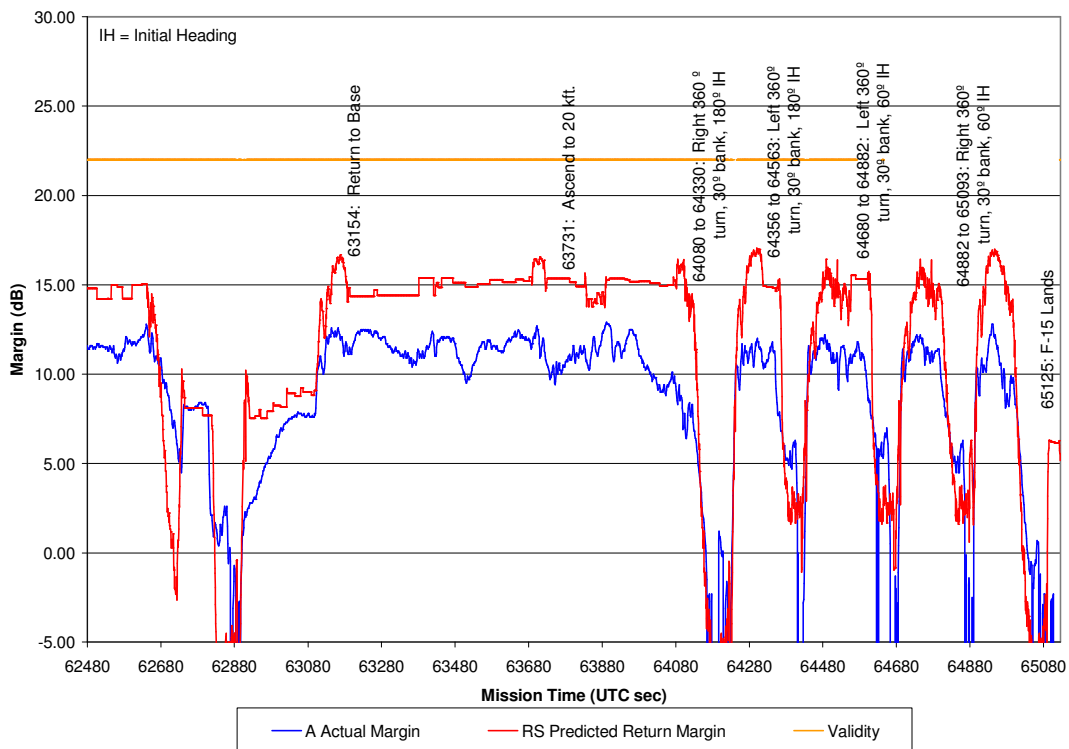
**Figure 4. Flight 6 RS Telemetry Link Margins**

Figure 4 and Figure 5 show the actual and predicted link margins versus time for the Range Safety TDRSS telemetry link during portions of Flights 6 and 7. These plots were chosen because they represent the performance of the Range Safety telemetry system after the additional power filtering was added for the HPAs. The STARS Final Report contains nearly 100 such plots for all the different link margins.

Note that the predicted values generally follow the actuals quite well, indicating that the attitude and trajectory data correlates well with the prediction models. The differences between the predicted and actuals are only 1 to 2 dB for Flight 6 and about 7 dB for Flight 7. The differences for Flights 1 to 5 were about 8 to 10 dB, with actuals being about 5 dB.

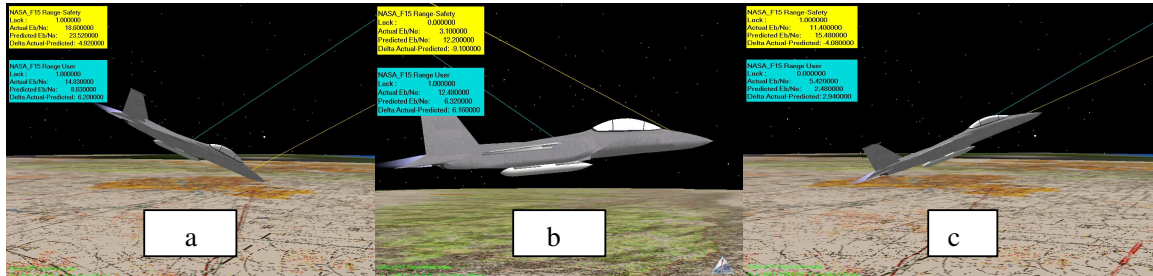
**Figure 6. No Blockage of Range User or Range Safety Links**

After the PRIMES testing was completed, additional STK simulations were performed to illustrate the blockage caused by the cockpit canopy. Figure 6 shows snapshots from Flight 7, which used TDRS-W for the Range User system and TDRS-171 for the Range Safety system. These pictures show vectors from the top antennas to the respective TDRSS satellites. Note that these are only vectors and not the full antenna pattern. Recall that the Range User antenna was located in the midsection of the aircraft and the Range Safety antenna was located on the nose of the aircraft.

In Figure 6a, there was no blockage of either the Range User or Range Safety links. In Figure 6b, there was no blockage of the Range User link, but the Range Safety link was blocked by the cockpit canopy. In Figure 6c, there was no blockage of the Range Safety link, but the Range User link was blocked by the cockpit canopy.
